From past to Crescent: Vinci refurbishes a Georgian gem

Vinci has had to do things the traditional way on a complex refurbishment of Buxton's Grade I-listed Crescent and Grade II-listed mineral baths

Project Buxton Crescent Hotel & Spa

Contractor Vinci

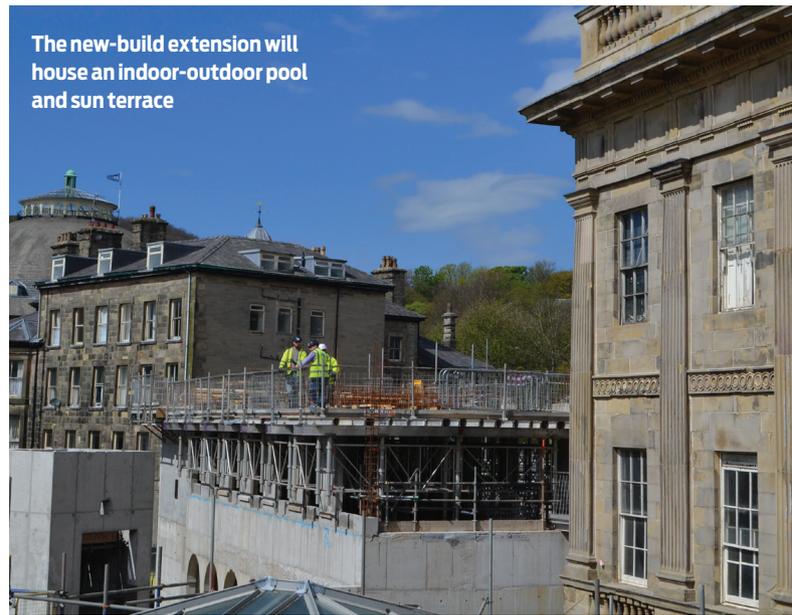
The new-build extension will house an indoor-outdoor pool and sun terrace

The contractor will also erect a new-build element adjoining the Crescent, clad in stonework from the same quarry used for the building's original construction.

This section of the building will act as an indoor-outdoor swimming pool, fed with natural water from the springs below, as well as a sun terrace.

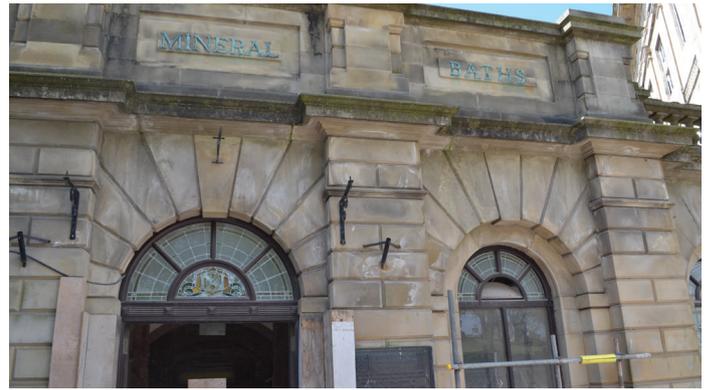
The adjoining mineral baths are a Grade II-listed building

A similar fate befell the adjoining Grade II-listed natural baths, which sit over the source of the town's famous mineral water. They have been largely empty since 1972, with only a tourist office remaining in part of the building until the early 2010s.

Both the new-build section of the building and the Grade II-listed natural baths, which Vinci is fully refurbishing as part of the job, sit almost directly above the source.
